NEW SITE IDENTIFICATION

2. Site Title: Test Area North Contaminated Soil Adjacent to 6-Inch Sanitary Sewer Line on West Side of TAN-615		
3. Describe the conditions that indicate a possible inactive or unreported waste site. Include location and description of suspicious condition, amount or extent of condition and date observed. A location map and/or diagram identifying the site against controlled survey points or global positioning system descriptors shall be included to help with the site visit. Include any known common names or location descriptors for the waste site. During excavation work around Test Area North (TAN)-615 conducted on July 15, 2002, D&D work crews came across soil overlying an active sanitary sewer line that was determined to be radiologically contaminated. Radiological control technicians surveyed a shovel full of the soil removed from the excavation using a hand-held Ludlum 2A instrument. The survey of the soil showed beta/gamma contamination in the range of 20,000 to 30,000 dpm. The location of the contaminated soil is approximately 10-11 ft below ground surface and approximately 5-ft outside the building's west wall (at a point corresponding to the southw

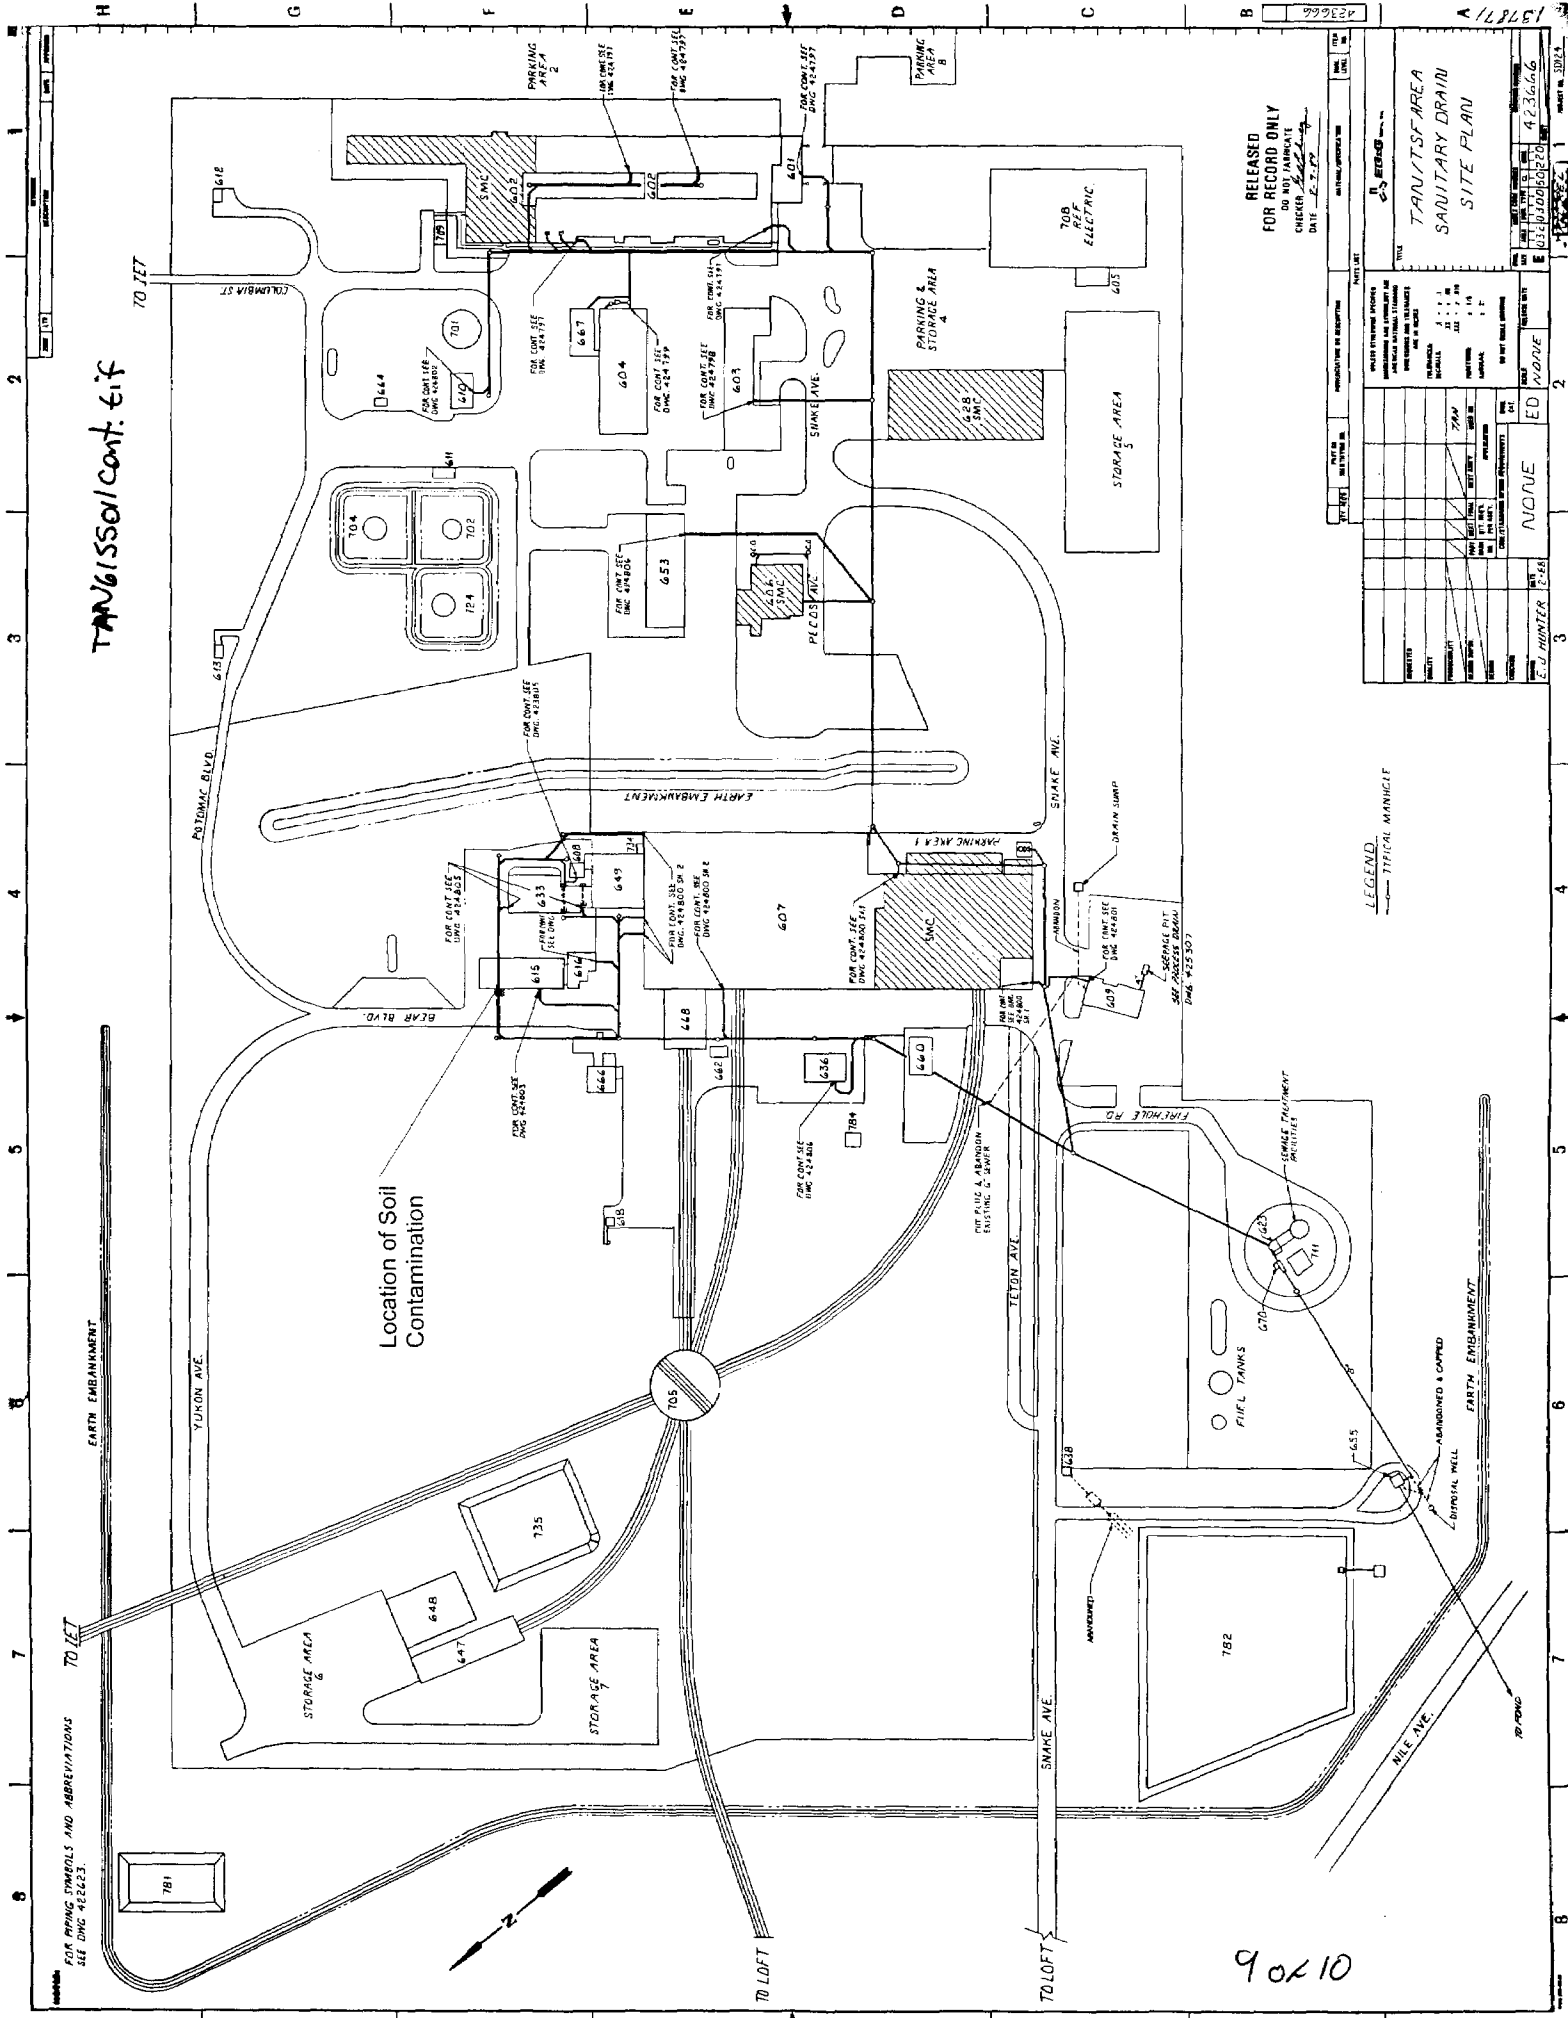
Location of Soil Contamination
